TECHNICAL INSPECTION REPORT

6 OPERATION CROSSROADS.
U.S.S. CRITTENDEN (APA 77)

TEST ABLE.

VOLUME 2 [U].

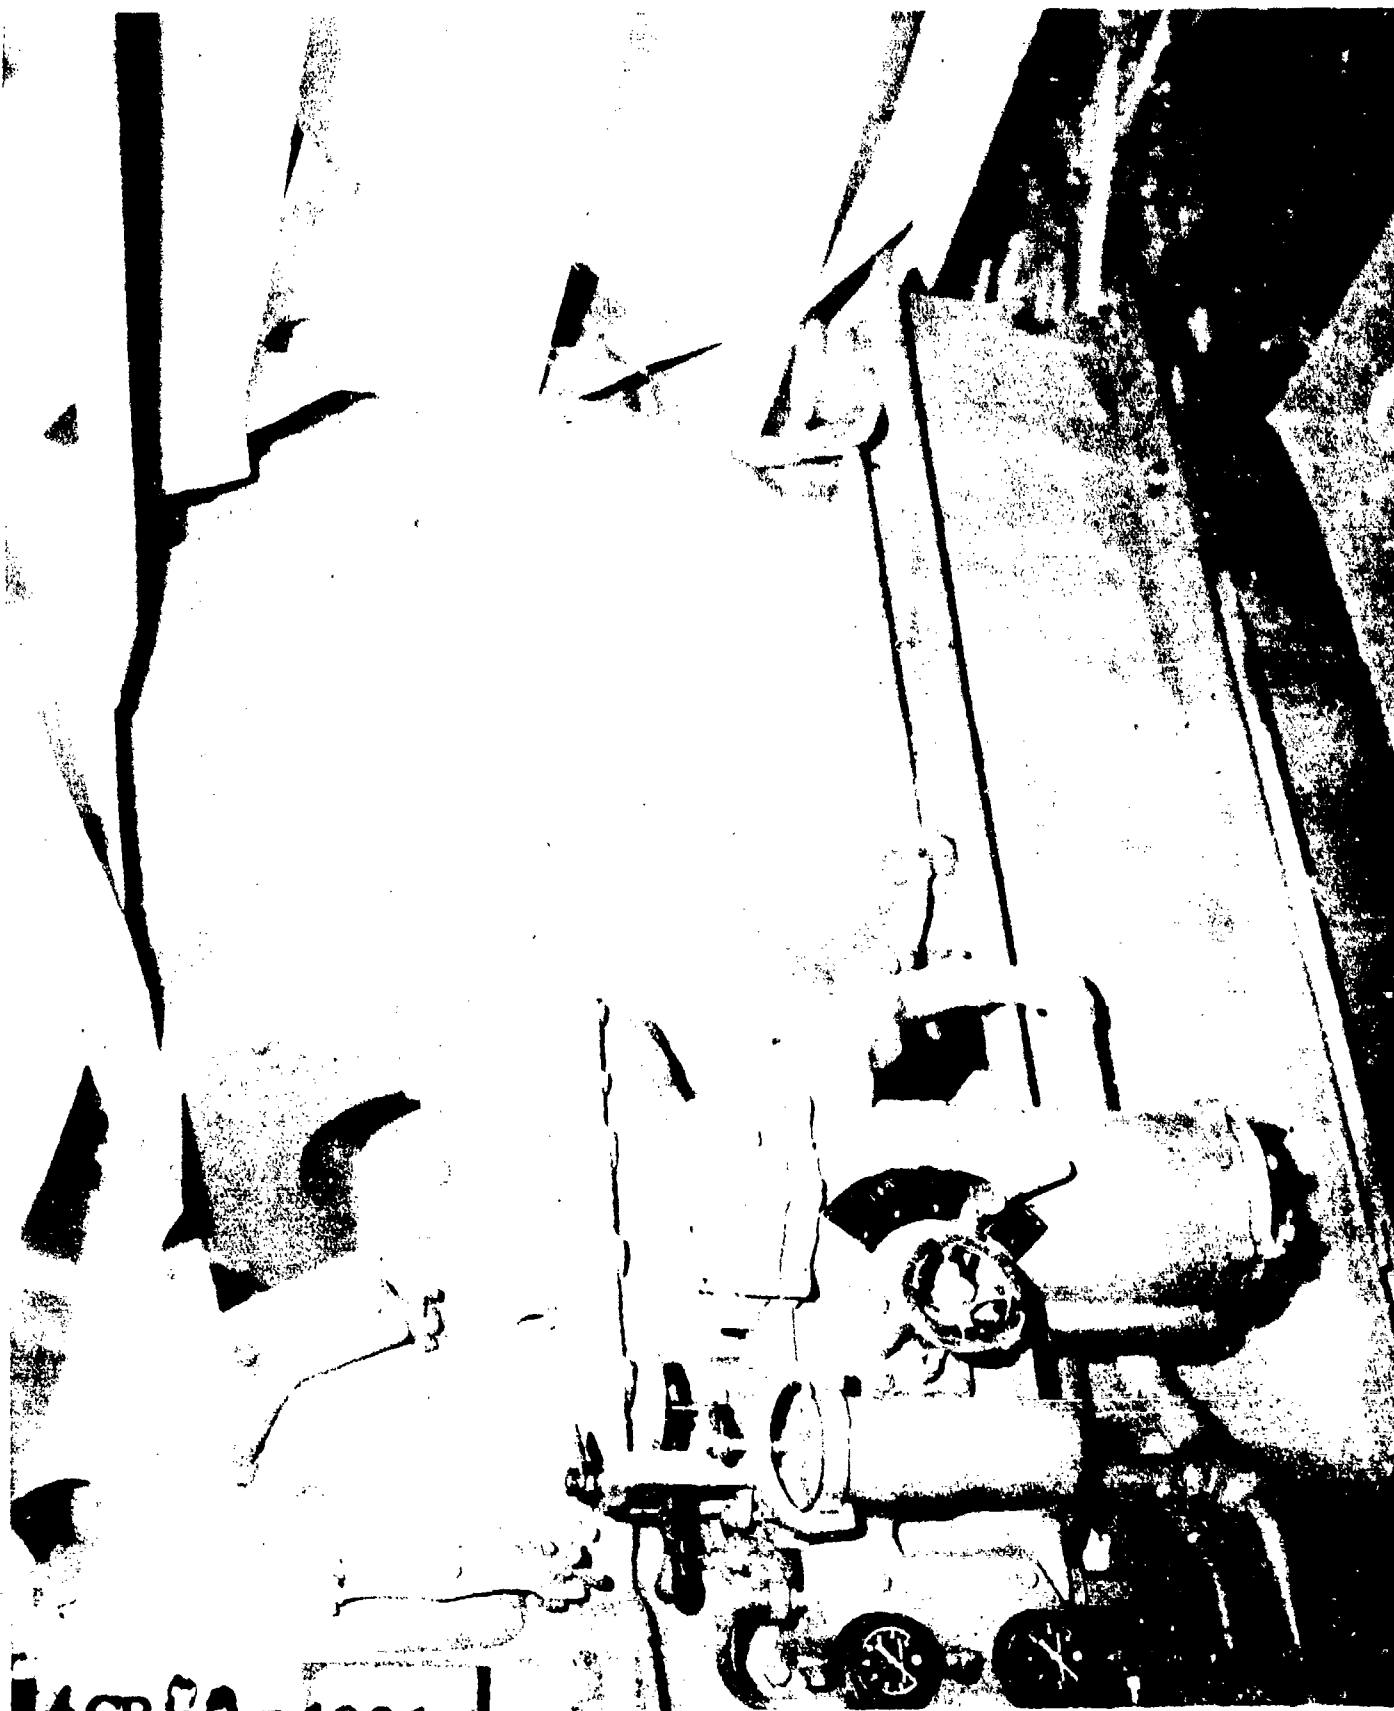
AA-CR-80-1901-4. 400 K.W. turbo generator located in the forward cargo hold. Shown before the debris was cleared away. Code 660, 12E1.

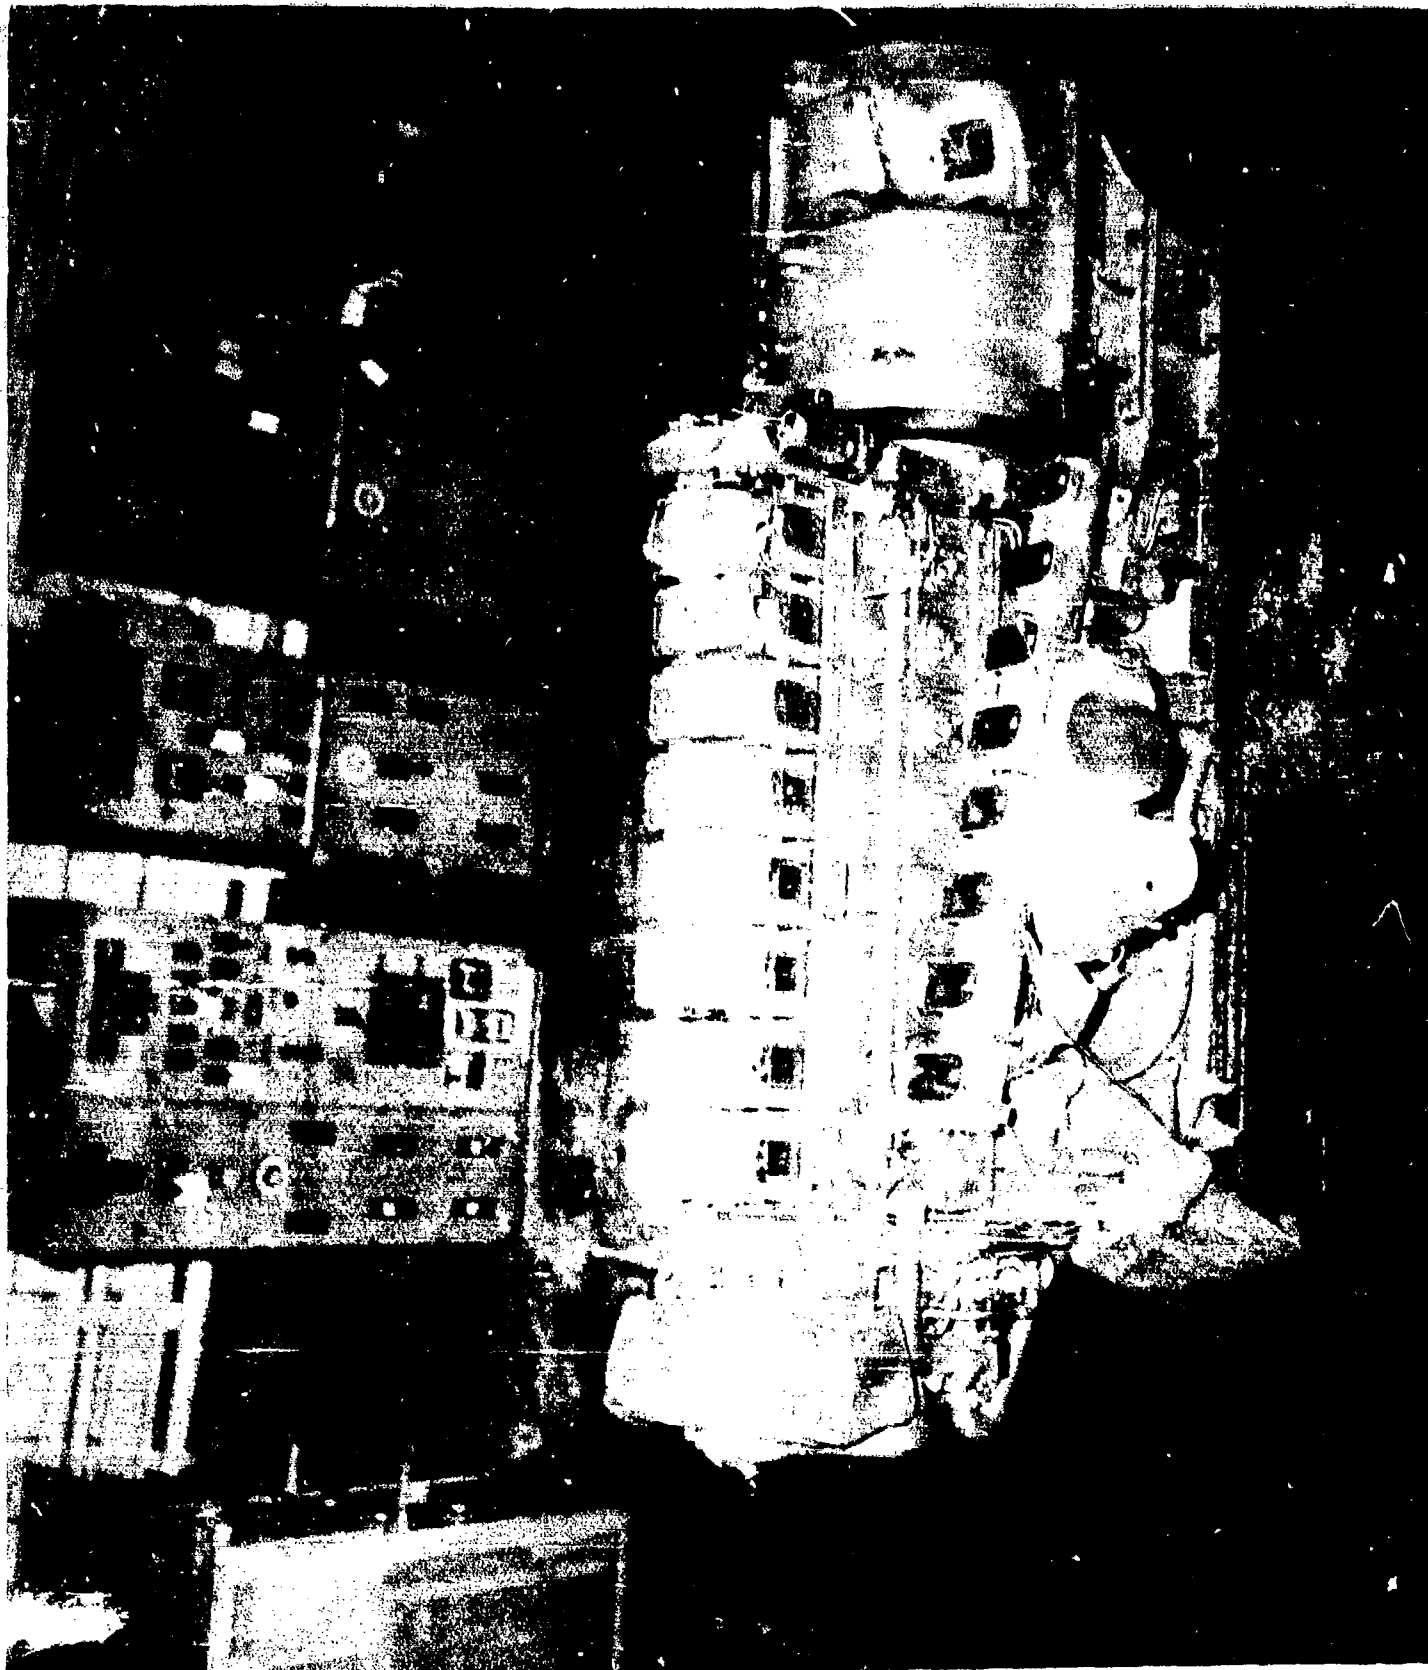
AA-CR-78-1948-11. 300 K.W. diesel generator set located in the forward cargo hold. Shown after the debris was cleared away. Code 660, 12E2.

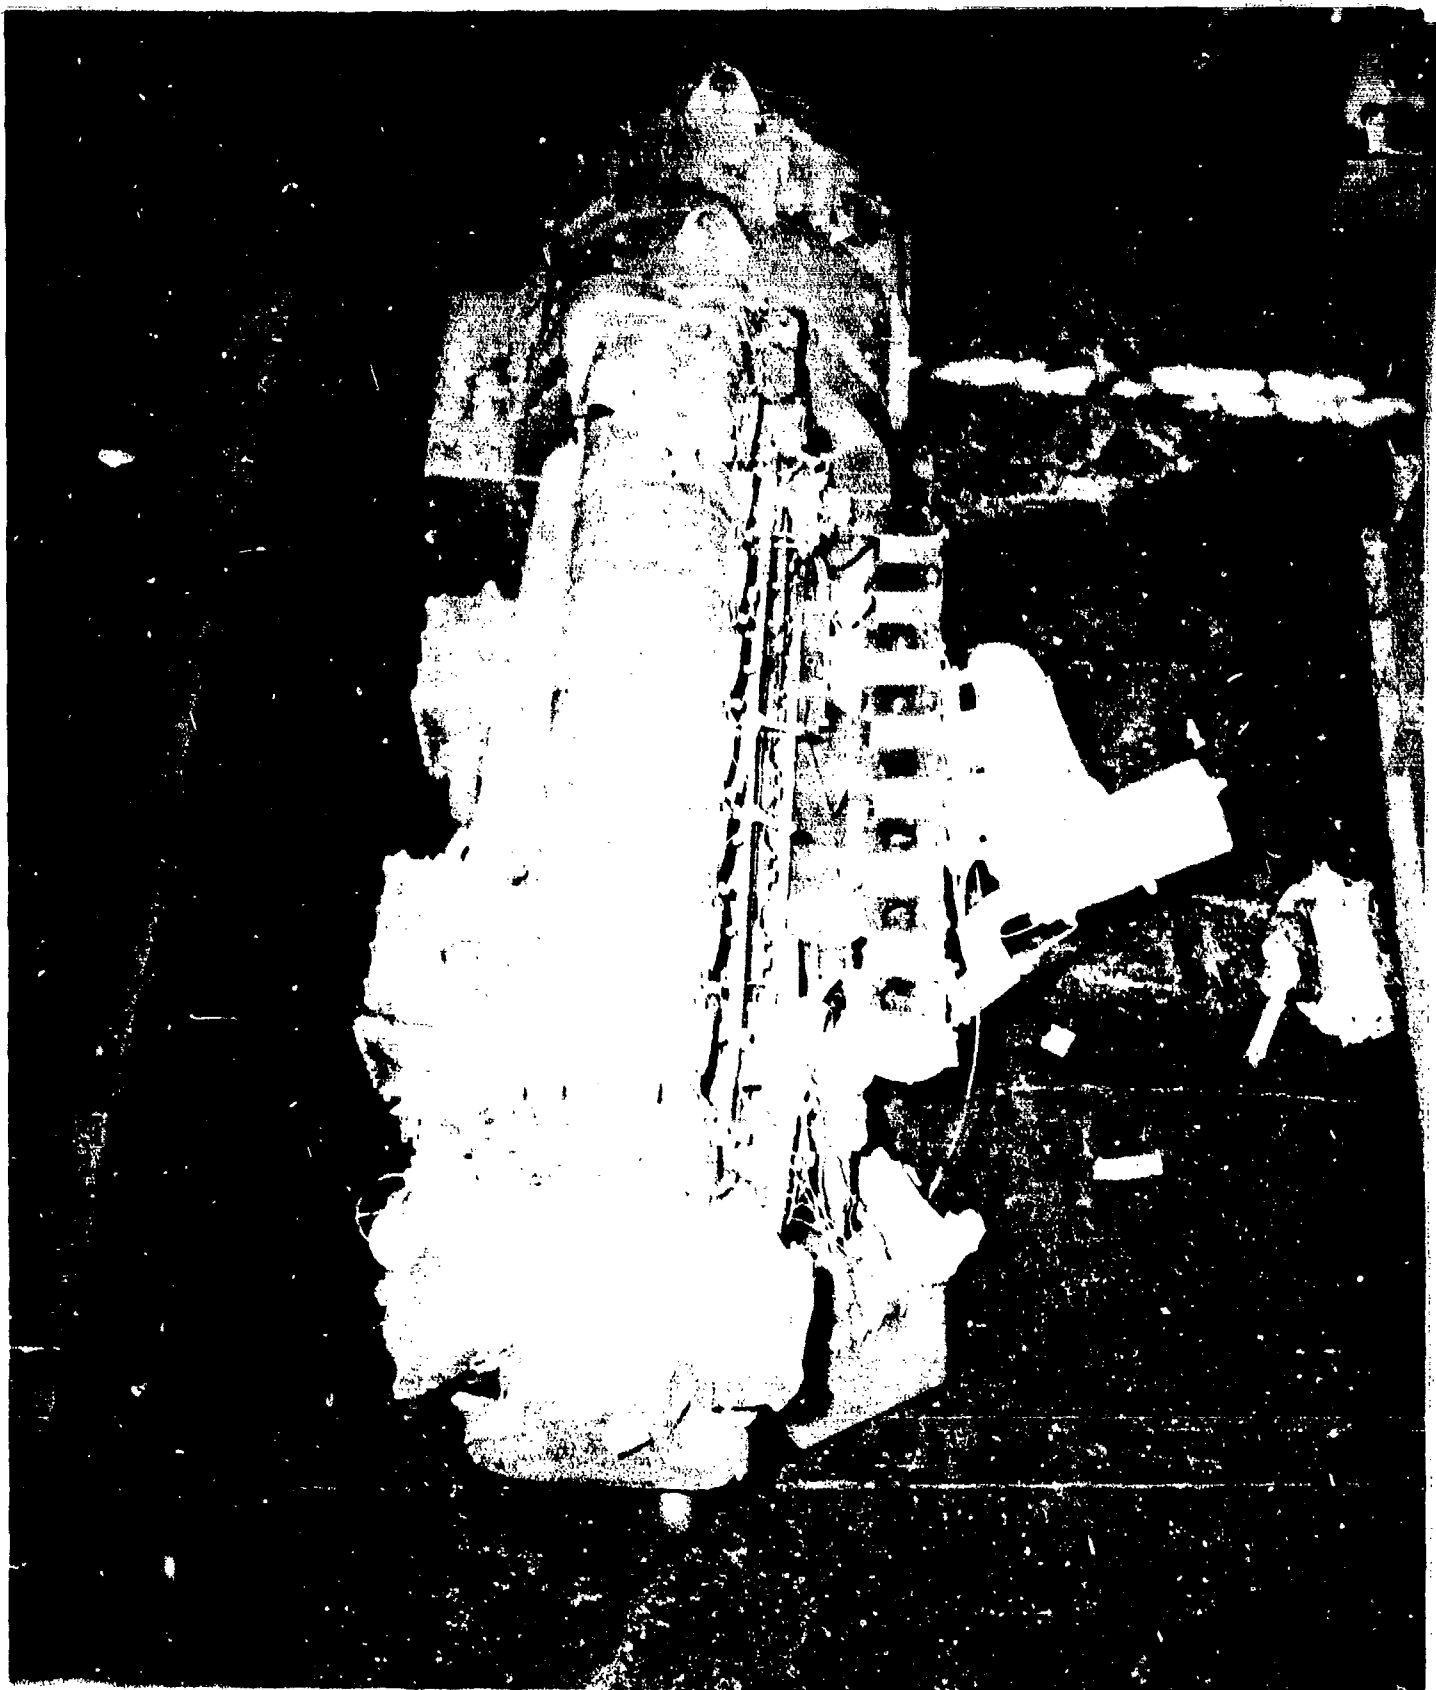
AA-CR-78-1949-1. 300 K.W. diesel generator set located in the forward cargo hold. Shown after the debris was cleared away. Code 660, 12E2.

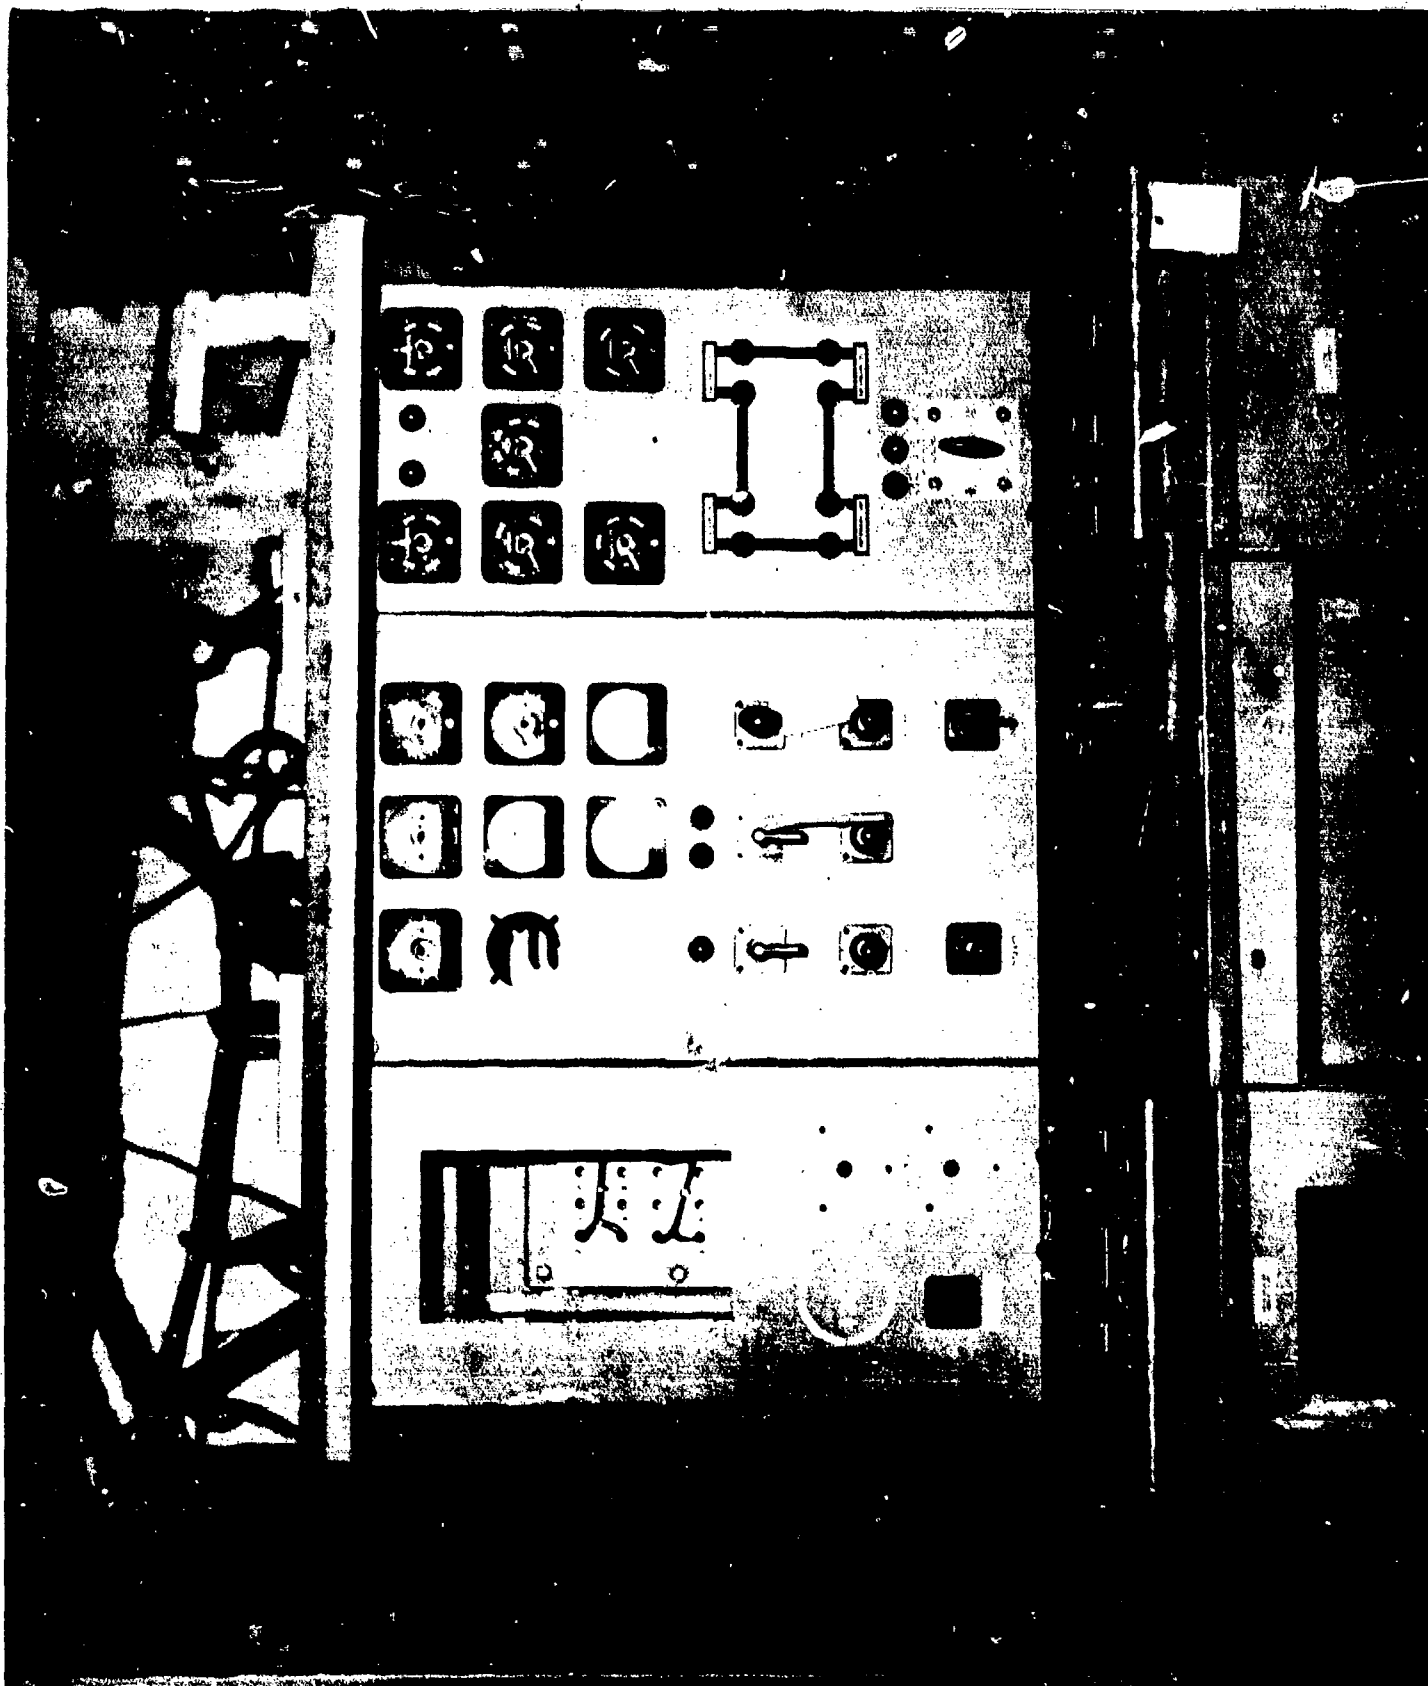
AA-CR-78-1949-10. CV9 class switchboard bench control panel.
Located in the forward cargo hold. Code 660, item 12E5.

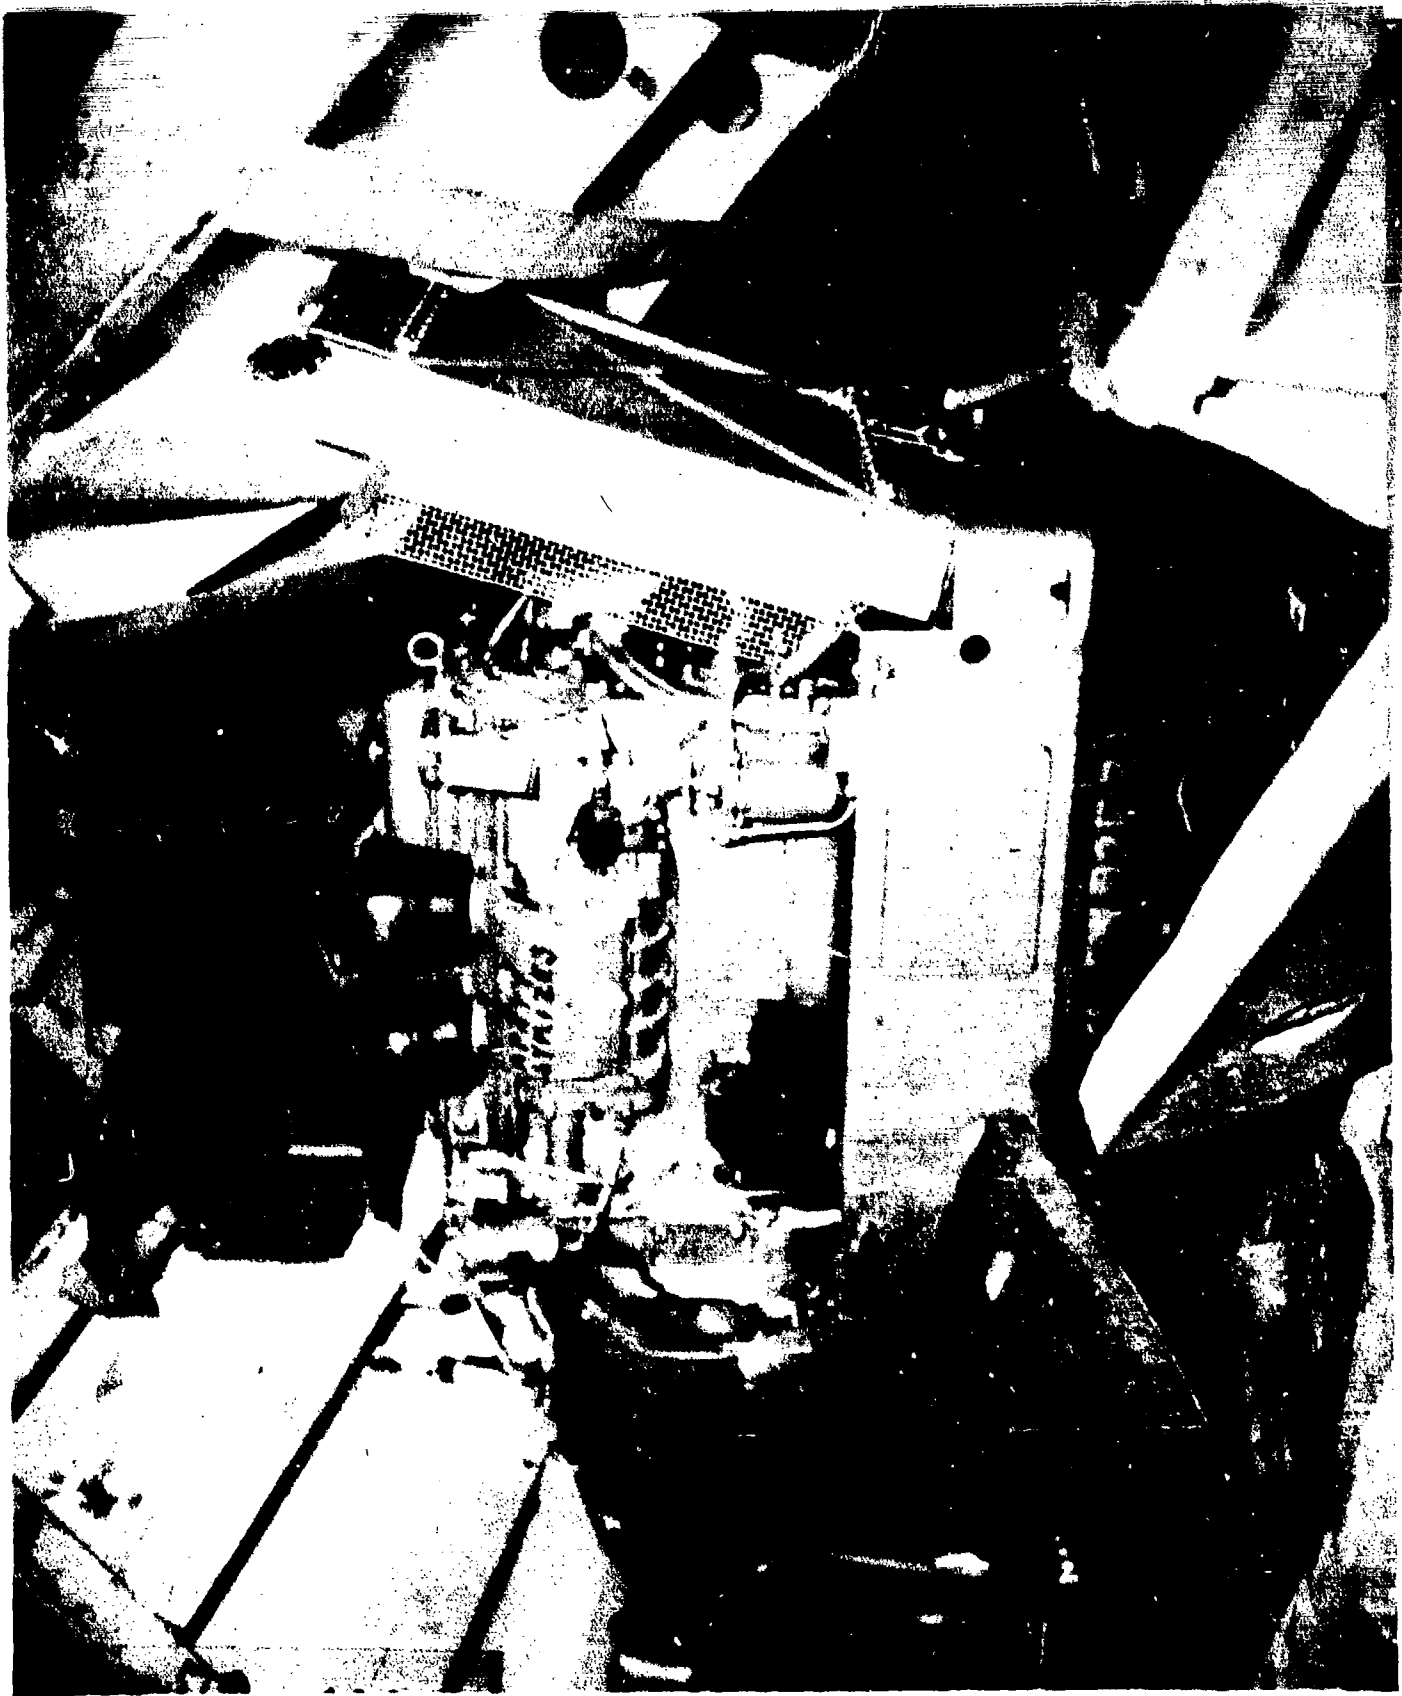
AA-CR-80-1901-1. Diesel generator located in the forward cargo hold. Shown before the debris was cleared away. Code 660, 12E3.

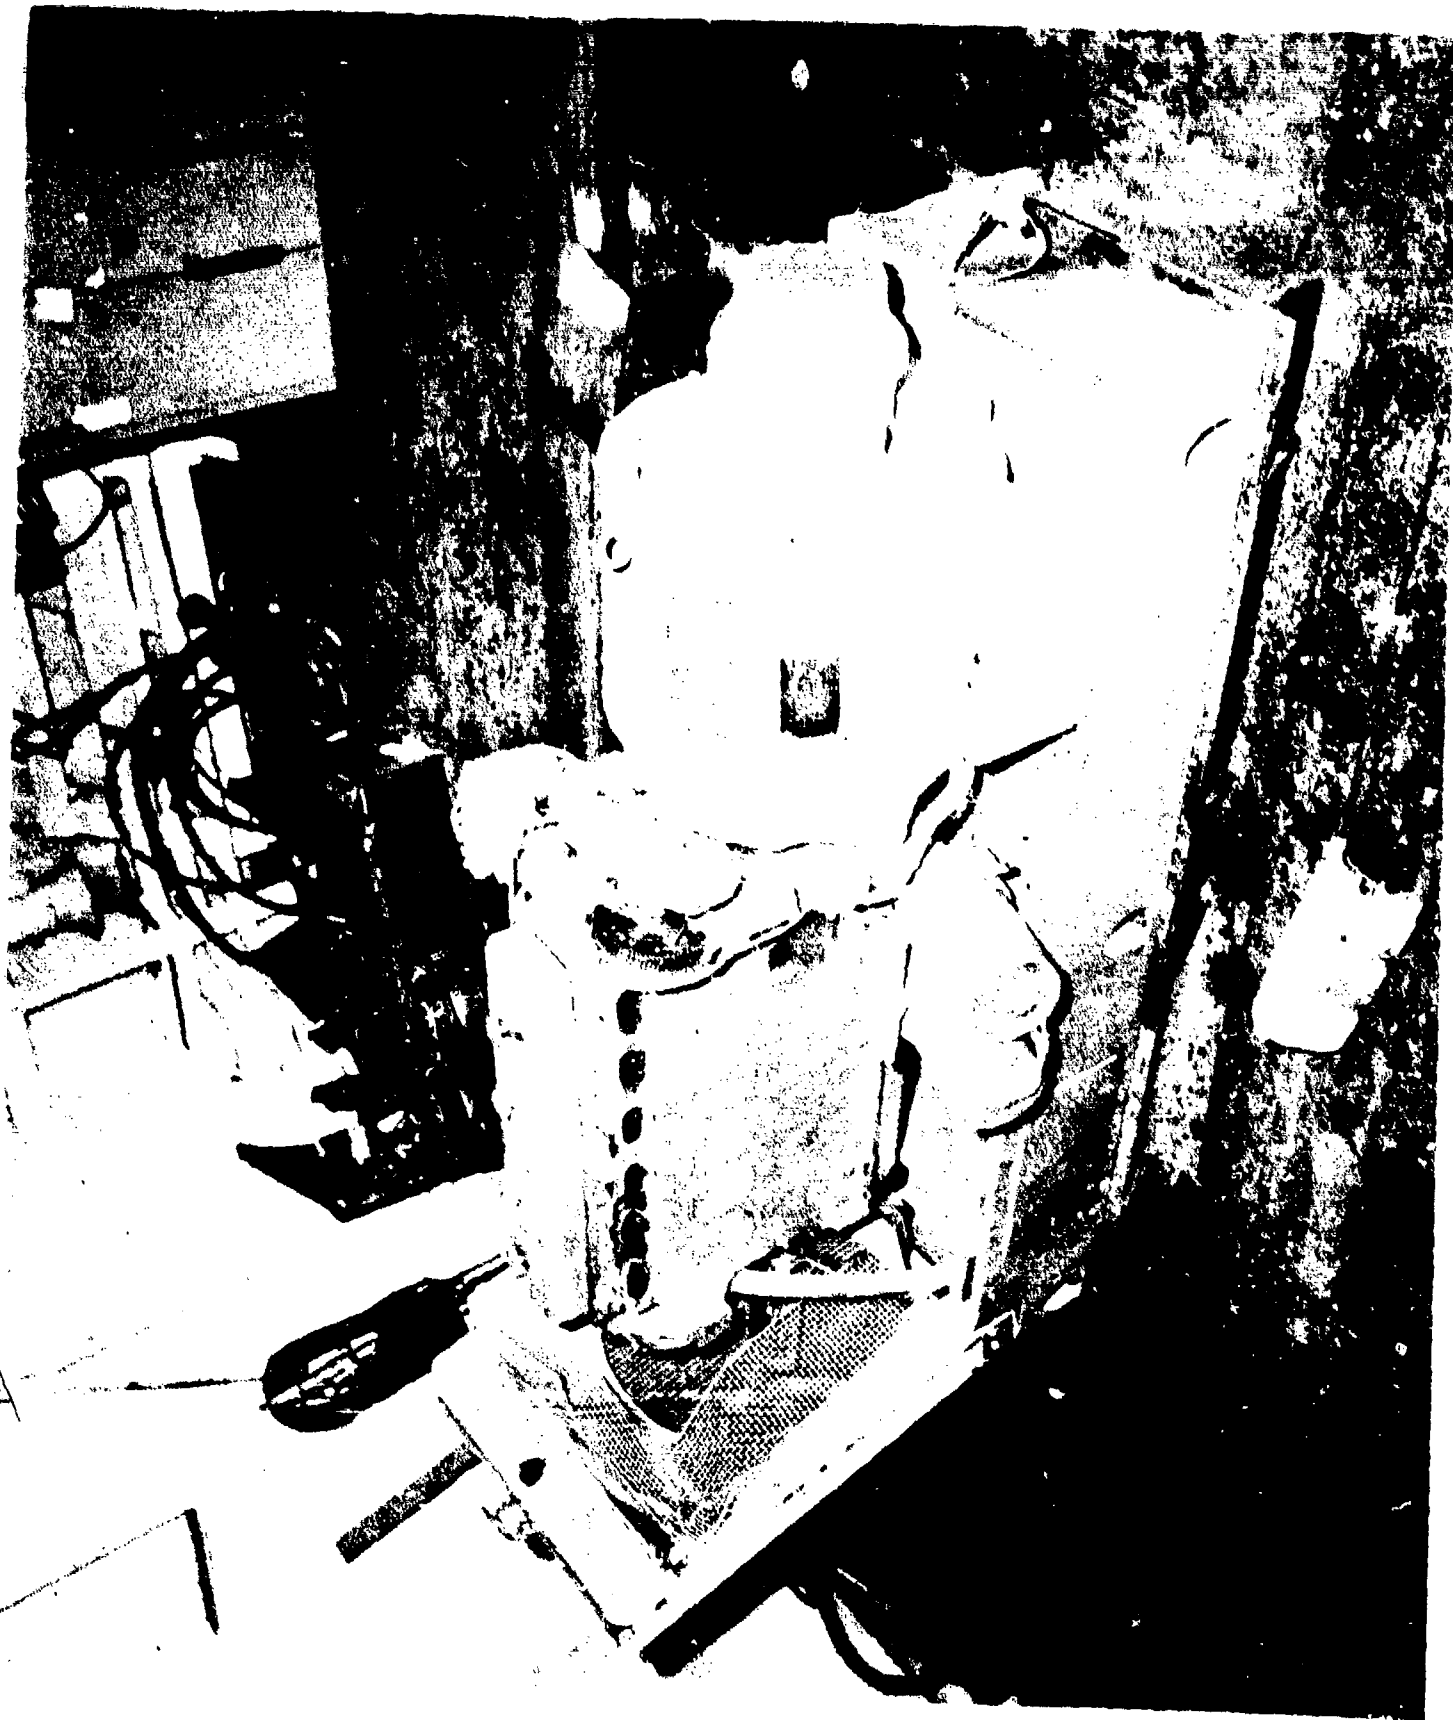
AA-CR-78-1949-3. Diesel generator located in the forward cargo hold. Shown after the debris was cleared away. Code 660, 12E3.

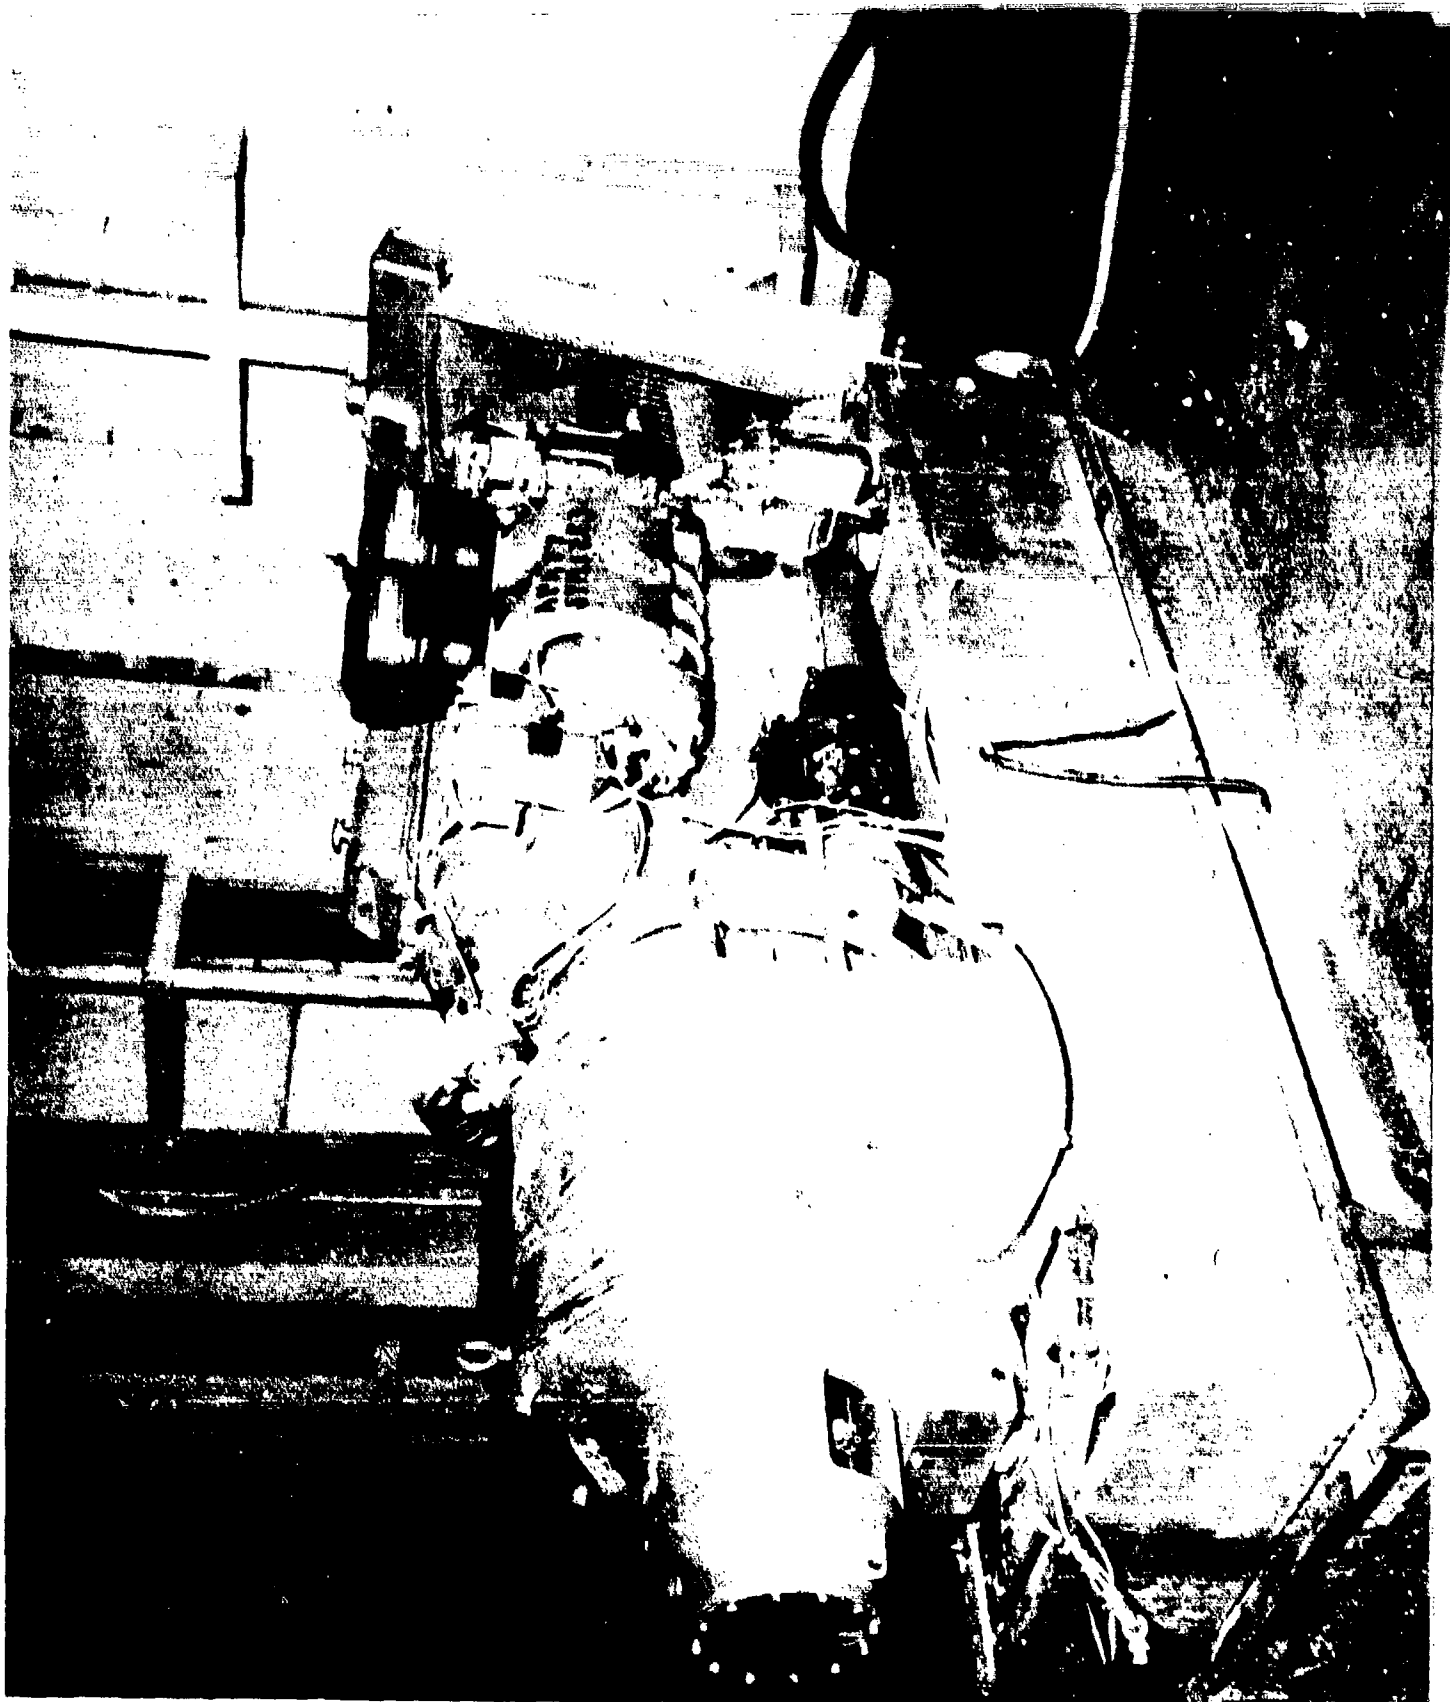
AA-CR-78-1949-4. Diesel generator located in the forward cargo hold.
Shown after the debris was cleared away. Code 660, 12E-3.

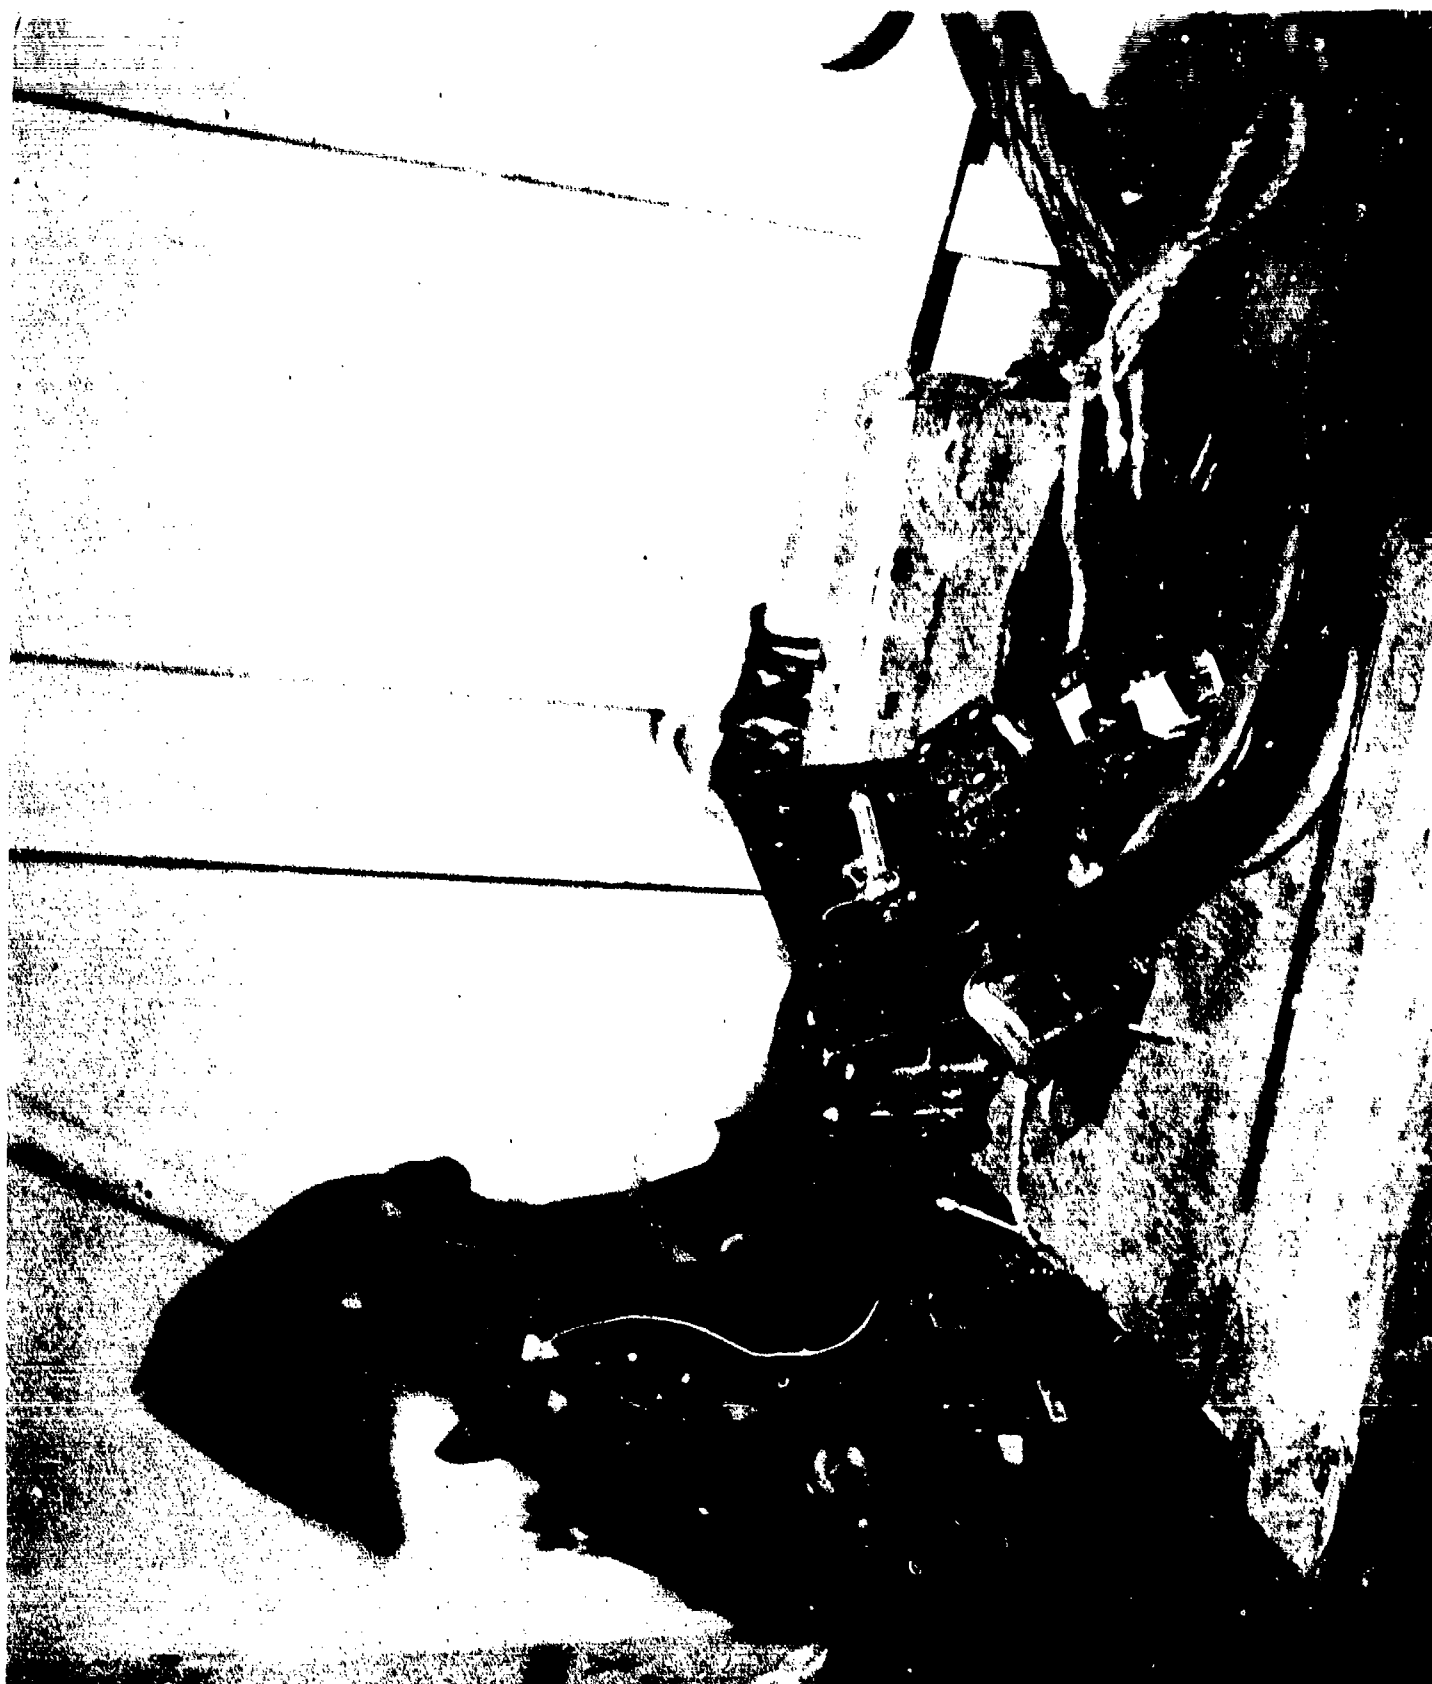
AA-CR-78-1949-11. Control panel for the diesel generator 12E3.
Located in the forward cargo hold. Shown after the debris was cleared
away.
